Geosynthetics
Tree Vitality Observations
Cellweb[®]TRP

Tree Vitality Assessment of historic Cellweb®TRP projects

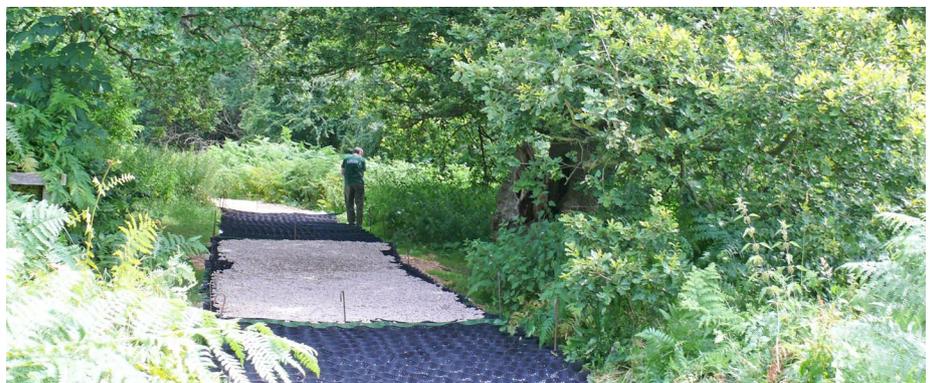
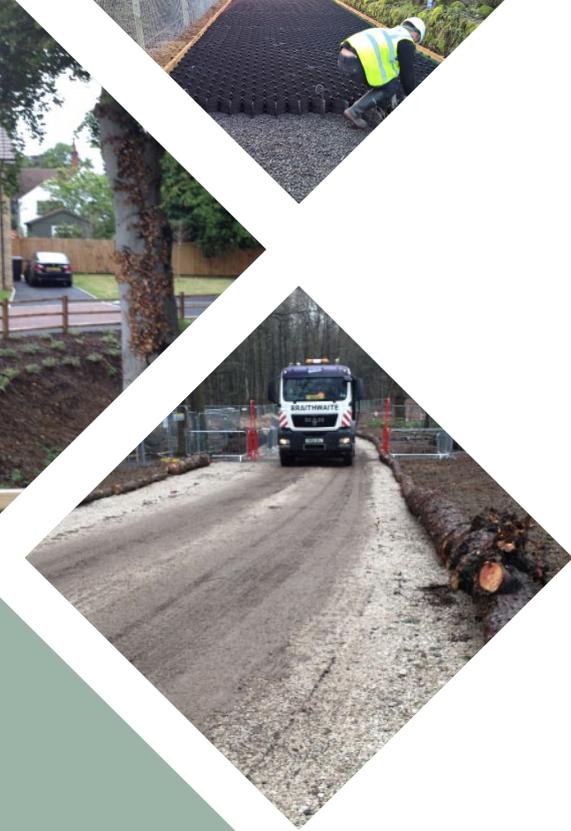
Lakeside Development

Leaf, needle and bud coverage: Needle cover is good and uniform throughout the crown.

Leaf and needle size shape and colour: Needle size and shape is normal for the species with good colour and no signs of curling or chlorosis.

Dead wood content: Minor deadwood was present throughout the crown which is typical for the species.

Bacterial or fungal colonisation: No evidence of bacterial or fungal colonisation was observed.

Other observations and comments: This tree is showing no ill effects from the installation of the Cellweb®TRP road through its RPA. A case study is available for this project.
