Tree Vitality Observations

Cellweb[®]TRP

2nd Edition

Tree Vitality Assessment of historic Cellweb® TRP projects

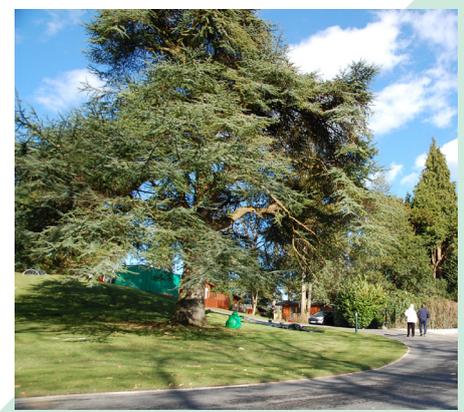
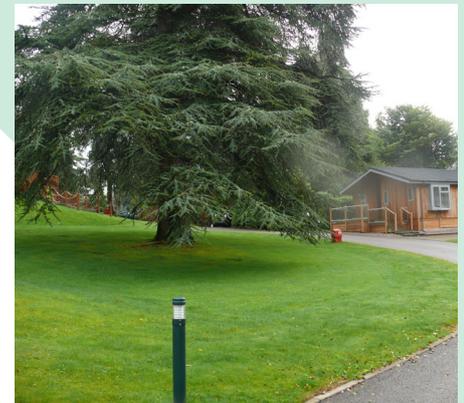
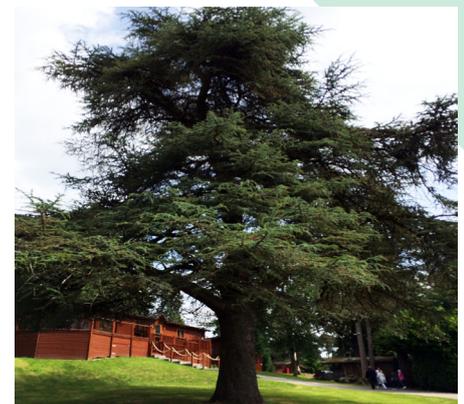
Tree species:	Atlas Cedar <i>Cedrus atlantica</i>
Project details:	This project involved the construction of a holiday park on the banks of lake Windemere. The site comprises numerous luxury chalets set amongst mature trees. Cellweb® TRP was used for the construction of the access roads around the new parks and was surfaced with a permeable asphalt. The photos show the tree at the time of installation and at the time of the 2015 and 2017 inspections.
Installation date:	18 th March 2011
Assessment date:	18th August 2015 and 17th July 2017
Leaf, needle and bud coverage:	Dense and even needle coverage was observed
Leaf and needle size shape and colour:	Needle shape and colour were normal for species.
Dead wood content:	Minor deadwood was observed in the inner crown. This can be considered normal for the species.
Bacterial or fungal colonisation:	No evidence of bacterial or fungal colonisation was observed.

Other observations and comments:	The tree is currently exhibiting no signs of ill health or reduced vitality.
Next assessment date:	Summer 2019

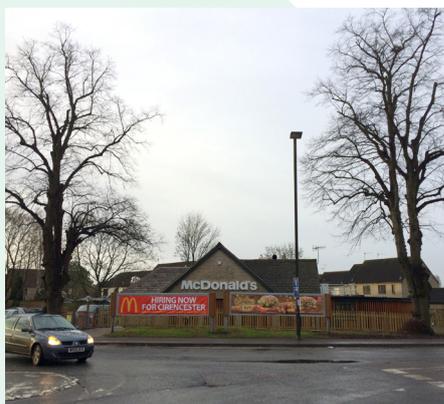
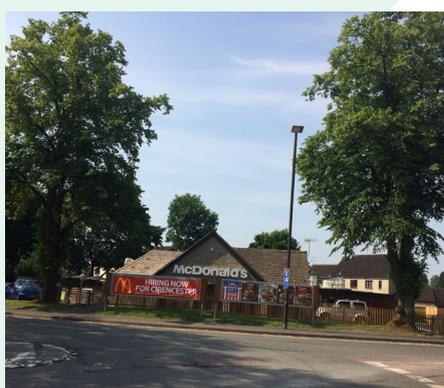
Tree species:	Common Lime <i>Tilia x europaea</i>
Project details:	In October 2016 McDonalds Cirencester embarked on a project to improve their parking facilities and drive through. This included the construction of a minimal dig Cellweb® footpath through the RPA's of two Lime trees. A full case study is available for this project.
Installation date:	October 2016
Assessment date:	20th June 2017
Leaf, needle and bud coverage:	Leaf coverage is good and even across the crowns.
Leaf and needle size shape and colour:	Leaf size is normal for species and colour is good.
Dead wood content:	A small amount of minor deadwood was observed throughout the crown. This could be considered normal for this species in this stage of its life cycle.
Bacterial or fungal colonisation:	No evidence of bacterial or fungal colonisation was observed on inspection.
Other observations and comments:	It can be observed that these trees have been subject to historic crown reduction. Some minor epicormic growth was observed on the main stems but this can be considered normal for species. The trees appear to have good vitality and although the inspection was carried out only eight months after installation, they will be monitored in the future.

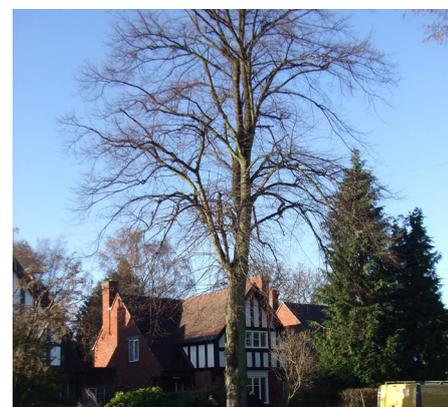
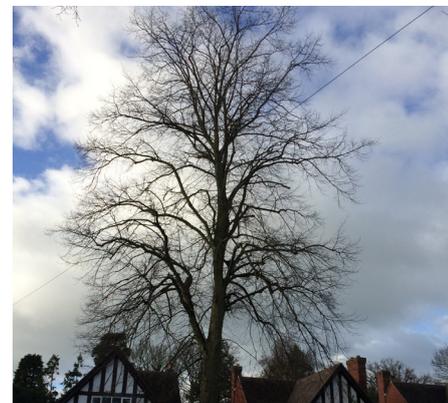
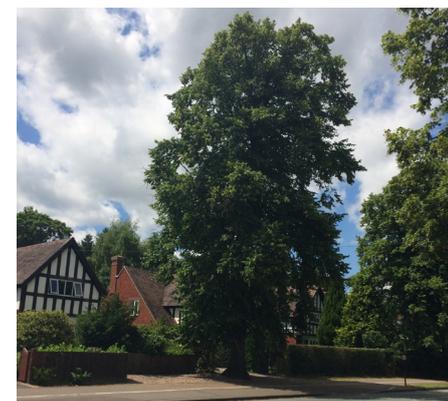
Tree species:	Common Lime <i>Tilia x europaea</i>
Project details:	In order to construct a driveway and create a garage the drive needed to pass through the RPA of a mature Lime. The photos above show the tree at the time of installation, in February 2016 and in July 2017. This has enabled us to view the tree in winter and in leaf.
Installation date:	5th December 2008
Assessment date:	3rd February 2016 and 5th July 2017
Leaf, needle and bud coverage:	The good bud coverage observed in December 2016 has provided good even leaf coverage in summer 2017.
Leaf and needle size shape and colour:	The leaf size, shape and colour is good and is normal for species.
Dead wood content:	Minor deadwood was observed throughout the crown which is common to the species at this stage in the life cycle.
Bacterial or fungal colonisation:	No fungal fruiting bodies or exudates were observed.
Other observations and comments:	In 2017 almost nine years after installation, this tree continues to exhibit signs of good vitality.

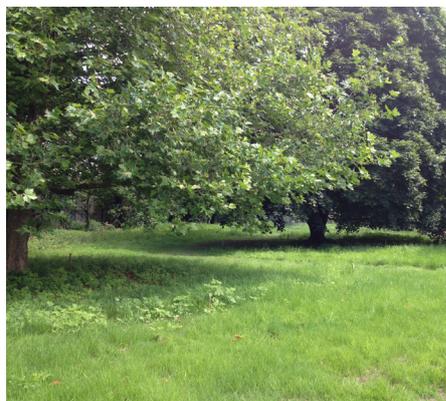
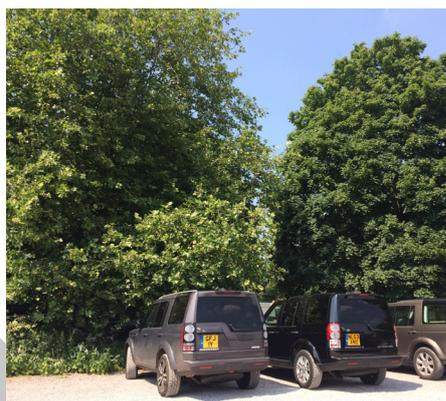
Tree species:	London Plane <i>Platanus x hispanica</i> and Sycamore <i>Acer pseudoplatanus</i>
Project details:	In December 2014 Parkside school embarked on the construction of a new carpark to increase capacity for staff and visitor parking. The 200mm Cellweb® was used to construct the minimal dig carpark and access road. The access road and carpark encroaches significantly into the RPA's of the trees photographed above. A full case study is available for this project.
Installation date:	December 2014
Assessment date:	20th June 2017
Leaf, needle and bud coverage:	Leaf size and coverage was good on both trees.
Leaf and needle size shape and colour:	Leaf size, shape and colour is good.
Dead wood content:	No deadwood was observed.
Bacterial or fungal colonisation:	No evidence of fungal or bacterial colonisation was observed.
Other observations and comments:	Two and a half years after the installation of the carpark these trees appear to be in good health with good vitality.

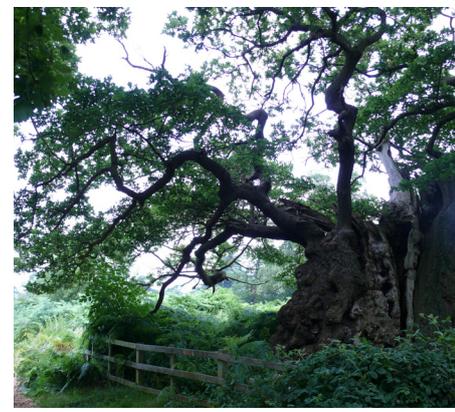
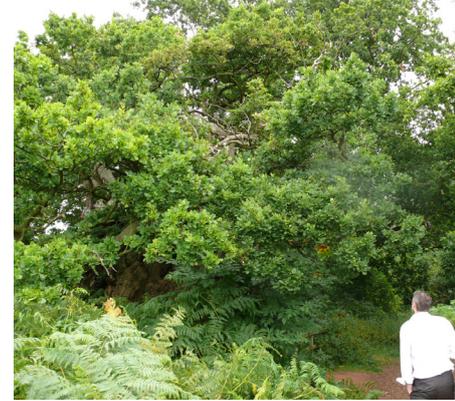
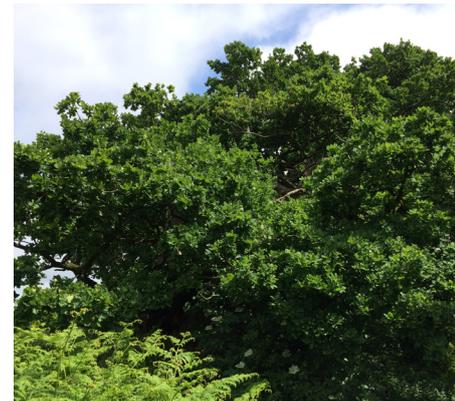
Project details: This 1200 year old oak at the national trusts Calke Abbey had been retrenching on one side due to soil compaction caused by long term foot traffic on one side of the crown. A Cellweb® footpath was created to replace the existing footpath and a layer of mulch was placed below the Cellweb® system to encourage the loosening and aeration of the compacted soil by decomposers and earth worms. The above pictures show the tree at the time of installation and on the dates of assessment in both 2015 and 2017.

Leaf, needle and bud coverage: Leaf coverage and crown density continues to improve. This can be attributed to improved soil conditions but also the removal of several surrounding trees at the time of installation.

Leaf and needle size shape and colour: Leaf size colour and shape was typical for species.

Dead wood content: As would be expected of a tree of this age and species there were significant quantities of major dead wood, most of which can be found on the footpath side of the crown. Although the tree is retaining its dead wood well, no additional deadwood was found suggesting a possible slowing in the trees retrenching through an improvement in soil conditions, increased light levels and reduced competition for water and nutrients.

Bacterial or fungal colonisation: No fruiting bodies or exudates were observed.

Other observations and comments: This tree continues to display an improvement in its vitality through improved soil conditions and reduced competition for light, water and nutrients.

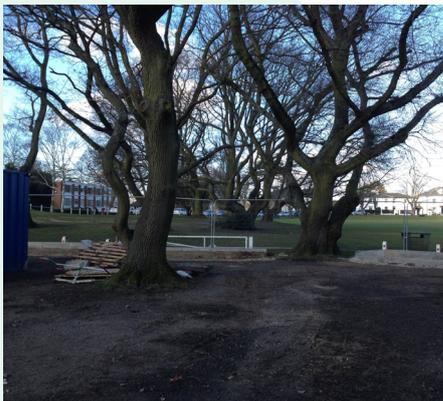
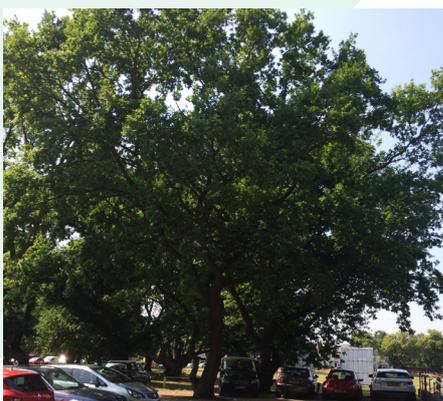
Project details: In March 2015 Elmbridge Borough Council began construction on a new car park at Weybridge cricket club. The carpark was constructed using a Cellweb® no dig subbase and was surfaced using the Geosynthetics Golpla® gravel retention system. The new carpark was constructed over a large proportion of the RPA's of the two oaks photographed.

Leaf, needle and bud coverage: The combined crowns have good even leaf coverage.

Leaf and needle size shape and colour: The leaf size and shape and colour is good.

Dead wood content: Only minor quantities of deadwood were observed, although it is standard practice to remove deadwood in such high target areas.

Bacterial or fungal colonisation: No evidence of bacterial or fungal colonisation was observed.

Other observations and comments: Two years on from the installation these trees appear to be in good health and exhibit good vitality.

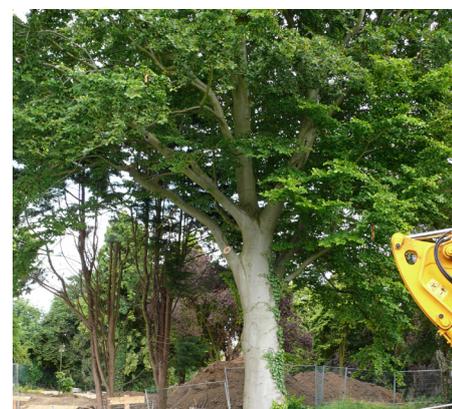
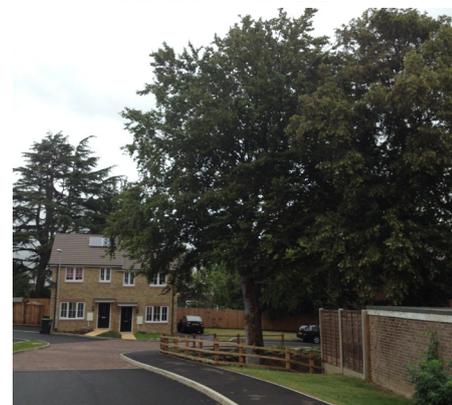
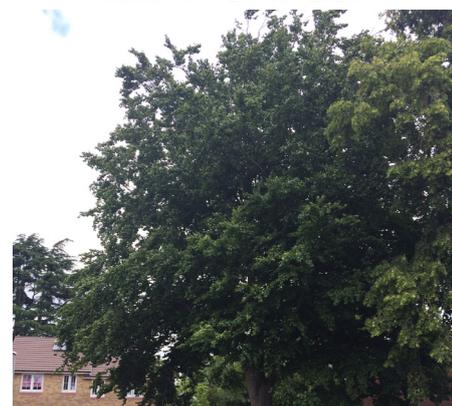
Tree species:	Common Beech <i>Fagus sylvatica</i>
Project details:	This project involved the construction of a new access road through the RPA of a Beech tree to access a new development site in Rushden, Northamptonshire. The project was unique at the time in that it required the stacking of the Cellweb® system to overcome changes in levels within the RPA in excess of 2M. This brought about a significant increase in levels within the RPA. The photos above show the tree at the time of installation and at the time of the 2015 and 2017 inspections.
Installation date:	26th June 2014
Assessment date:	14th August 2015 and 13th June 2017
Leaf, needle and bud coverage:	Leaf coverage was good and even throughout the crown.
Leaf and needle size shape and colour:	Leaf size, shape and colour was normal for species.
Dead wood content:	No major dead wood was observed however low levels of minor deadwood were observed throughout the crown.

Bacterial or fungal colonisation:	No fruiting bodies or exudates were observed on inspection.
Other observations and comments:	It can be seen in 2017 that this tree continues to exhibit no signs of reduced vitality or ill health caused by this installation.
Next assessment date:	Summer 2019

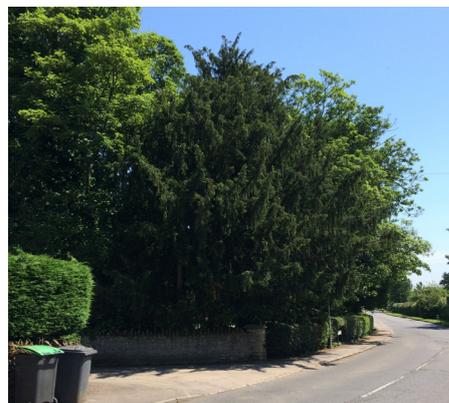
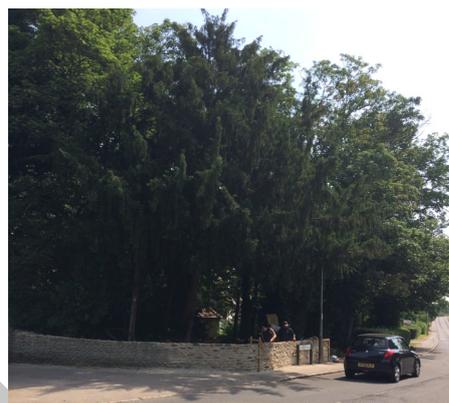
Tree species:	English Yew <i>Taxus baccata</i>
Project details:	In summer 2016 a new driveway was constructed within the RPA of an English yew. Much of the RPA was located in a natural depression which was in excess of 1m below the road level and the proposed drive beyond. The construction required a build up of five layers of Cellweb® 200mm to infill the depression and meet the existing road level. A full Case study is available for this project.
Installation date:	June 2016
Assessment date:	6th July 2017
Leaf, needle and bud coverage:	This tree has good needle coverage. As would be expected needle coverage is more sparse on the trees shade side.
Leaf and needle size shape and colour:	Needle size and colour is normal for the species.
Dead wood content:	No significant deadwood was observed, although this may have been removed at the time of the crown raising operation.
Bacterial or fungal colonisation:	No exudates or fruiting bodies were observed.

Other observations and comments:	The tree has been crown raised during the construction of the visual splays onto Church Lane. One year on from the installation this tree appears to be in good health with good vitality.
Next assessment date:	Summer 2019

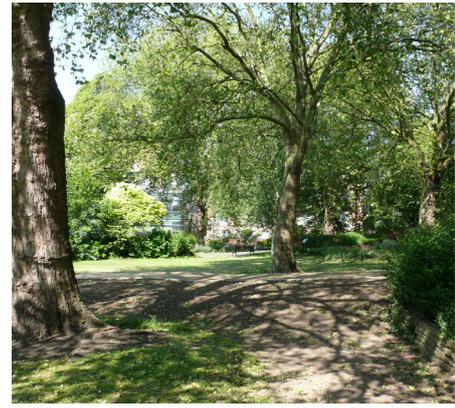
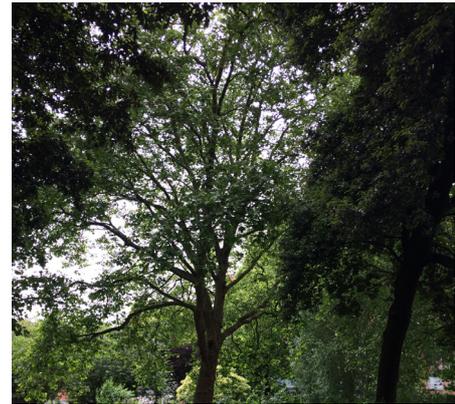
Tree species:	London Plane <i>Platanus x hispanica</i>
Project details:	In spring 2015 Leicester City Council constructed a new footpath linking St Nicholas Circle with the Castle Gardens. Due to natural changes in levels this required a multiple layer build up, utilising different depths of Cellweb®. The footpath passes through the RPA of the above photographed London Plane. A full case study is available for this project.
Installation date:	April 2015
Assessment date:	13th June 2017
Leaf, needle and bud coverage:	The tree has good even leaf coverage.
Leaf and needle size shape and colour:	Leaf size, shape and colour is normal for species
Dead wood content:	Minor deadwood was observed in the inner crown but this can be considered normal for the species.
Bacterial or fungal colonisation:	No bacterial cankers, exudates or fungal fruiting bodies were observed.
Other observations and comments:	The tree exhibits no significant defects and displays good vitality.

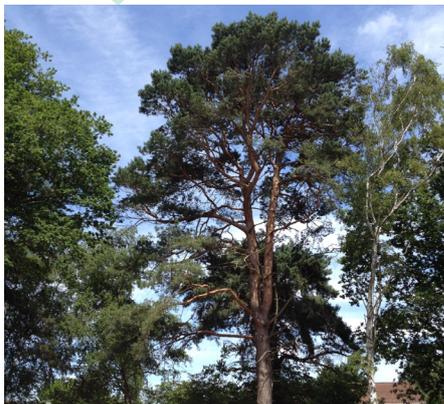
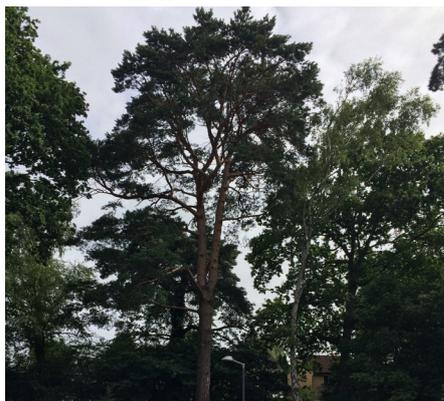
Tree species:	Scots Pine <i>Pinus sylvestris</i>
Project details:	As part of an overall redevelopment, Montacute school constructed additional parking for visitors and staff. The carpark is constructed using Cellweb® in order to protect the RPA's of trees which were retained around the peripheries of the carpark. The above Scots Pine is one of those trees with its RPA partially covered by the new carpark.
Installation date:	August 2015
Assessment date:	5th July 2017
Leaf, needle and bud coverage:	The tree has good even needle coverage in the upper canopy. Needle coverage is more sparse in the lower canopy which is likely to be caused by shading.
Leaf and needle size shape and colour:	The needle size shape and colour is normal for the species.
Dead wood content:	Very little deadwood was observed and it is likely that deadwood was removed before construction during the tree work operations.
Bacterial or fungal colonisation:	No evidence of bacterial or fungal colonisation was observed.

Other observations and comments:	Although the carpark was only installed very recently we can see that the installation has had no immediate adverse effects on tree vitality.
Next assessment date	Summer 2019
