Tree Vitality Observations

Cellweb[®]TRP

3rd Edition

Tree Vitality Assessment of historic Cellweb® TRP projects

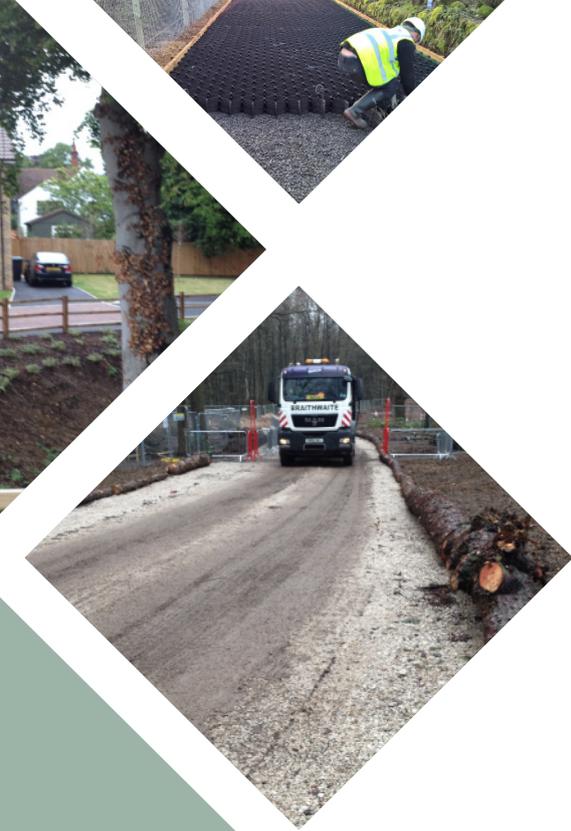
Lakeside Development

Tree species:	Atlas Cedar <i>Cedrus atlantica</i>
Project details:	This project involved the construction of a holiday park on the banks of lake Windemere. The site comprises numerous luxury chalets set amongst mature trees. Cellweb® TRP was used for the construction of the access roads around the new park and was surfaced with a permeable asphalt. The photos show the tree at the time of installation and at the time of the 2015, 2017 and 2020 inspections. A full case study is available for this project.
Installation date:	18 th March 2011
Assessment dates:	18th August 2015, 17th July 2017 and 27th July 2020
Leaf, needle and bud coverage:	Dense and even needle coverage was observed
Leaf and needle size shape and colour:	Needle shape and colour were normal for species.
Dead wood content:	Minor deadwood was observed in the inner crown. This can be considered normal for the species.
Bacterial or fungal colonisation:	No evidence of bacterial or fungal colonisation was observed.

Other observations and comments:	The tree exhibits historic storm damage, which could be expected in this exposed location on Lake Windemere. However, the tree shows no signs of ill health or reduced vitality.
Next assessment date:	Summer 2022

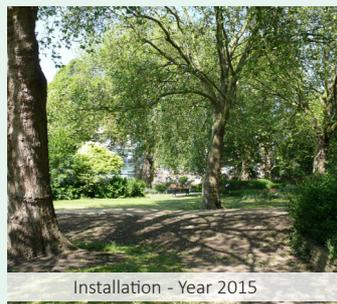
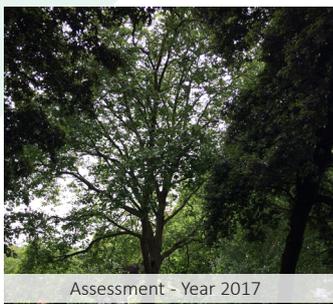
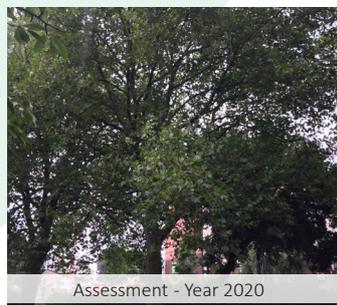
Castle Gardens

The crown is asymmetric, caused by a neighbouring tree to the north. Despite this, leaf coverage is good.

Minor deadwood was observed in the inner crown but this can be considered normal for the species.

No signs of reduced vitality were observed.

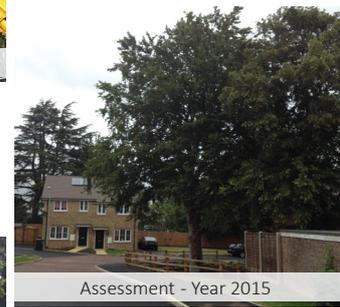
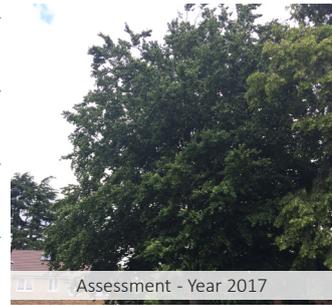
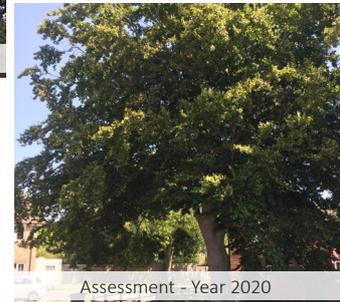
Keats Way

Leaf coverage was good and even throughout the crown.

Minor deadwood was observed, evenly dispersed throughout the crown.

The tree exhibits no signs of reduced vitality. It was observed that crown spread is greater than in the 2015 and 2017 assessments.

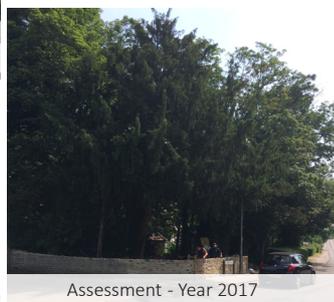
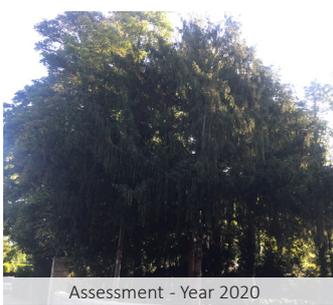
69 Church Lane

This tree has good needle coverage. As would be expected needle coverage is more sparse on the trees shade side.

No significant deadwood has formed since the 2017 inspection.

The tree has been crown raised during the construction of the visual splays onto Church Lane. Crown spread is greater than that observed in 2016 and 2017.

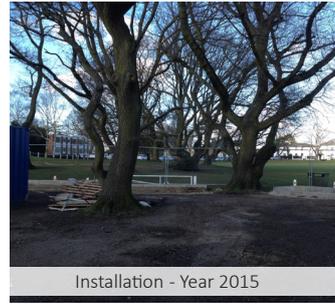
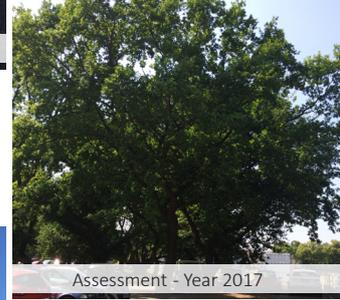
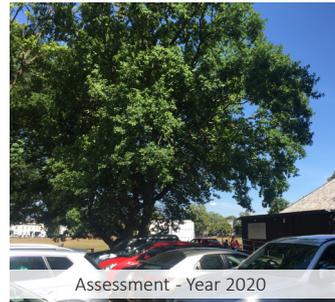
Weybridge Cricket Club

Tree species:	English Oak <i>Quercus robur</i>
Project details:	In March 2015 Elmbridge Borough Council began construction of a new car park at Weybridge cricket club. The carpark was constructed using a Cellweb no-dig subbase and was surfaced using the Geosynthetics Golpla gravel retention system. The new carpark was constructed over a large proportion of the RPA's of the two oaks photographed.
Installation date:	March 2015
Assessment date:	20th June 2017 and 22nd July 2020
Leaf, needle and bud coverage:	The combined crowns have good even leaf coverage.
Leaf and needle size shape and colour:	The leaf size and shape and colour is good.
Dead wood content:	Minor deadwood was observed throughout the crowns of both trees. This can be considered normal. The most northerly tree has a more substantial piece of deadwood in the inner crown (approximately 75mm diameter). This is likely to have formed due to shading within the inner canopy.

Bacterial or fungal colonisation:	No evidence of bacterial or fungal colonisation was observed.
Other observations and comments:	No signs of reduced vitality were observed and both trees exhibit a good crop of acorns.
Next assessment date:	Summer 2022

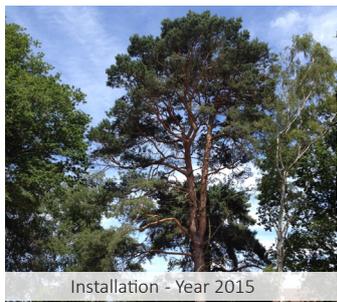
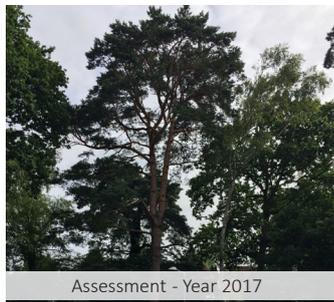
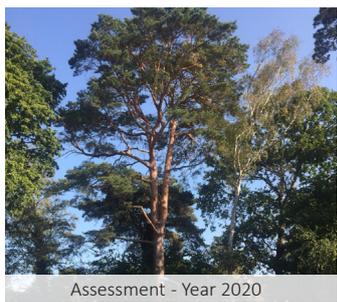
Montacute School

Tree species:	Scots Pine <i>Pinus sylvestris</i>
Project details:	As part of an overall redevelopment, Montacute school constructed additional parking for visitors and staff. The carpark is constructed using Cellweb® in order to protect the RPA's of trees which were retained around the peripheries of the carpark. The above Scots pine is one of those trees with its RPA partially covered by the new carpark.
Installation date:	August 2015
Assessment date:	5th July 2017 and 18th September 2020
Leaf, needle and bud coverage:	The tree has good even needle coverage in the upper canopy. Needle coverage is more sparse in the lower canopy which is like to be caused by shading and some minor storm damage at 7m south west.
Leaf and needle size shape and colour:	The needle size shape and colour is normal for the species.
Dead wood content:	Minor deadwood was observed in the central canopy, which can be considered normal.

Bacterial or fungal colonisation:	No evidence of bacterial or fungal colonisation was observed, although dense bramble prevented thorough basal inspection.
Other observations and comments:	This tree continues to exhibit good vitality.
Next assessment date	Summer 2020
