Case Study

Geosynthetics Pre-seeded Erosion Control Blankets

M40 Junction 15,
Longbridge Island
Relief Road

Water course realignment

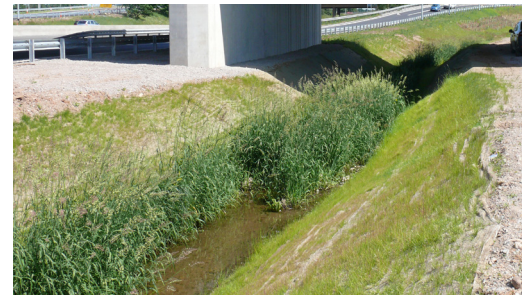
The flexitex was laid out in the pre profiled channel cut and then filled with pumped grout. The Flexitex was then buried with a 300mm covering of clay, stone and alluvium. To provide further erosion control and to restore the appearance of the watercourse the channel was then profiled to the same specification as the adjoining channel with Geosynthetics' pre-planted coir rolls and pre-seeded GeoSeed coir blankets.

Elsewhere on this very large project further channels were lined with more of our pre-planted coir rolls and GeoSeed pre-seeded blankets as well as our Rockrolls. Our matting is made purely from natural

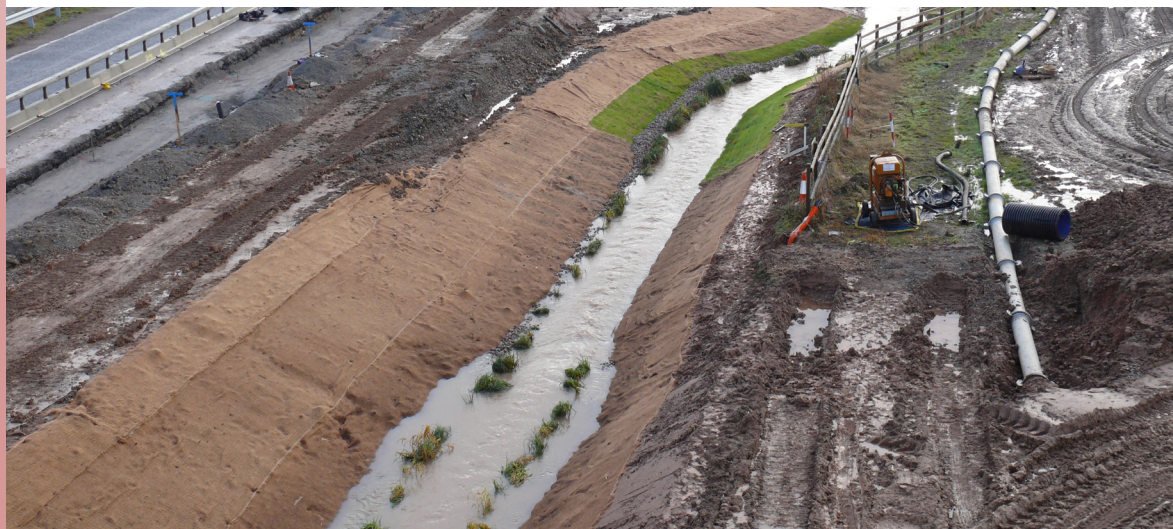
Now that the installation is complete the watercourse has rapidly returned to its natural appearance.
