STUDY

TTE National Trust Fell Foot (2) Access Road

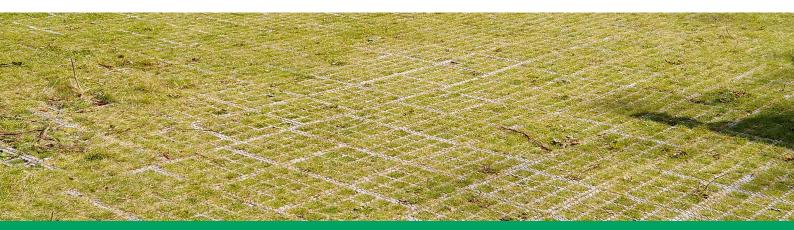
Even the heaviest loadings did not cause any deformation to the surface due to TTE®'s unique interlocking system and excellent load distribution.

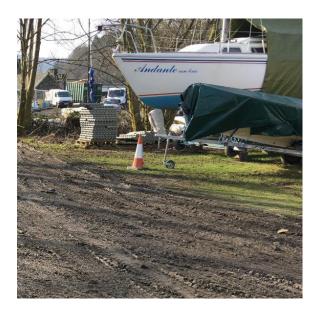
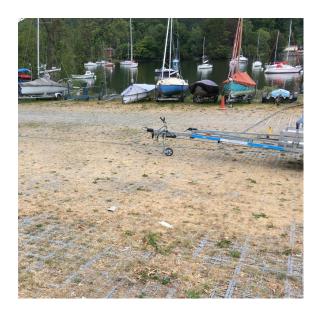
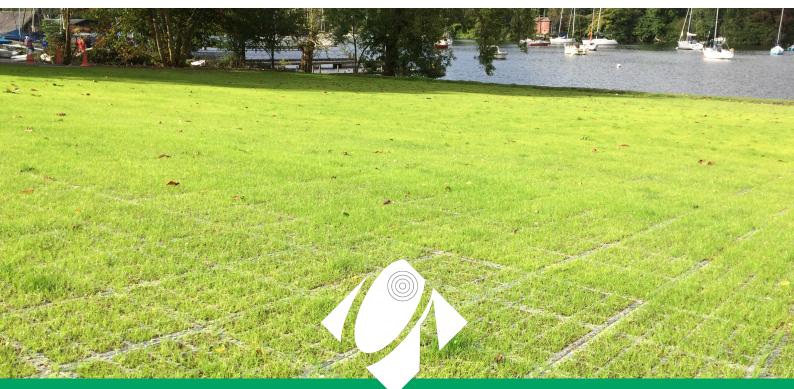
The heavy loadings caused the area to become quite muddy with soil from the tyres of the machines. In November 2017 this was further exacerbated by the weather as some areas of Cumbria saw in excess of 200mm of rain fall in less than 24 hours.

The long dry spell in 2018 that affected green areas across the UK also left the grass within the TTE units looking quite parched and withered. However the roots were still protected within the systems chambers so the grass did not die.

By November 2018 the recovery was on the way and the green grass returned. Some over seeding will be needed but overall the surface looks really good and is performing well.
