Geosynthetics
Tree Vitality Observations
Cellweb[®]TRP

Tree Vitality Assessment of historic Cellweb®TRP projects

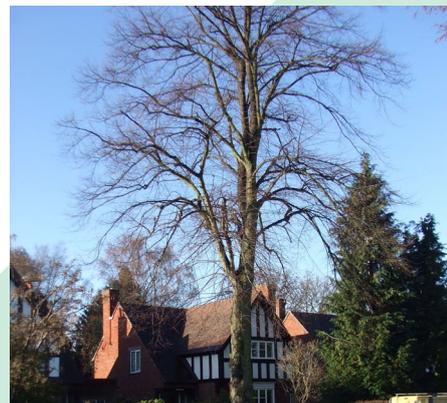
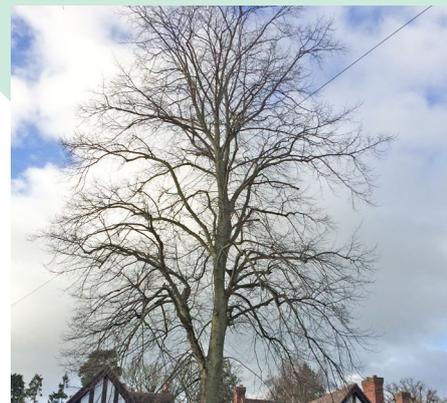
| Dead wood content: | Minor deadwood was observed throughout the crown which is common to the species at this stage in the life cycle. |
| Bacterial or fungal colonisation: | No fungal fruiting bodies or exudates were observed. |
| Other observations and comments: | Eight years on from the time of installation this appears to be a healthy tree with good vitality. |
