STUDY

TOTAL TRAFFIC EXOPAVE (TTE) National Trust Fell Foot Car Park

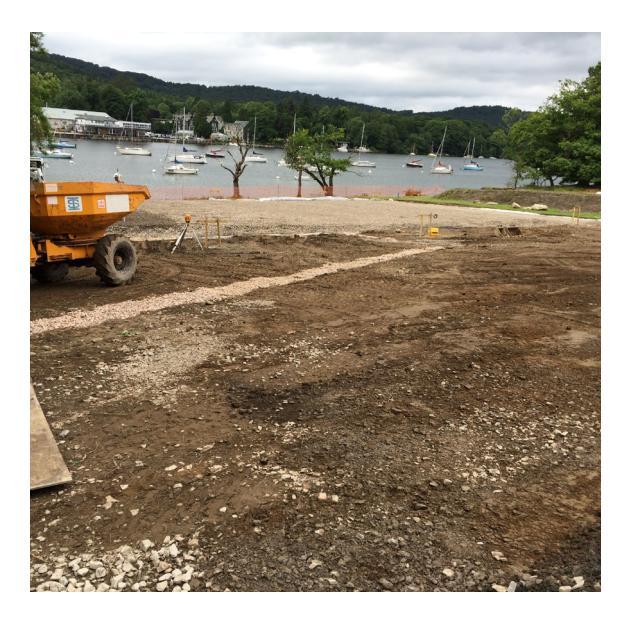
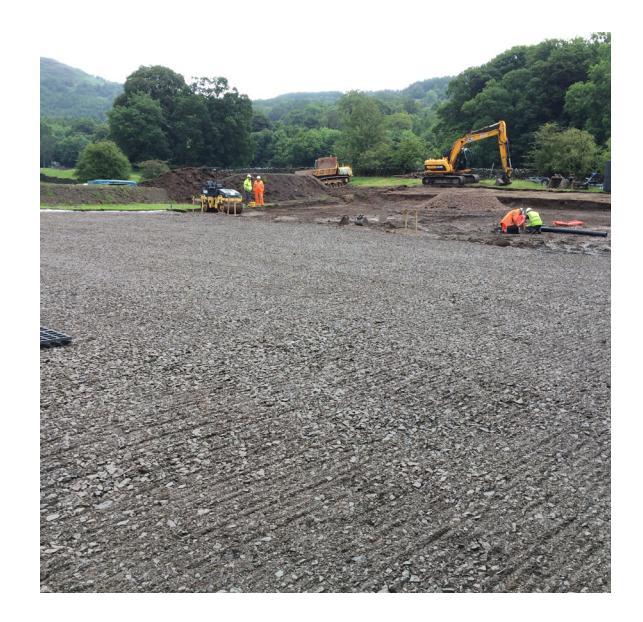
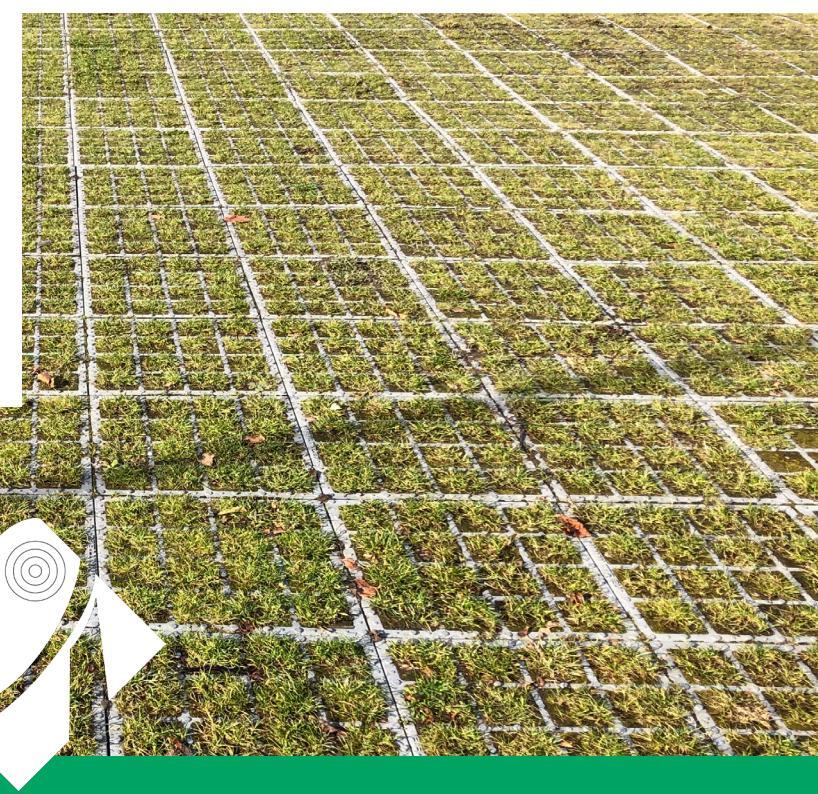
By November 2018 the recovery was on the way and the green grass returned. Some over seeding will be needed but overall the surface looks really good and is performing well. This showcases how versatile and robust the TTE® system can be whilst still supporting the loadings required.

During its first year, part of the TTE surface unexpectedly became an access road in and out of the site compound. This was used by a variety of construction equipment including excavators and dumpers. In addition to site equipment, the surface also catered for cars, vans, minibuses and 4x4's pulling heavy 3 axle trailers with boats. Even the heaviest loadings did not cause any deformation to the surface due to TTE®'s unique interlocking system and excellent load distribution.

The heavy loadings caused the area to become quite muddy with soil from the tyres of the machines. In November 2017 this was further exacerbated by the weather as some areas of Cumbria saw in excess of 200mm of rain fall in less than 24 hours. The long dry spell in 2018 that affected green areas across the UK also left the grass within the TTE units looking quite parched and withered. However the roots were still protected within the systems chambers so the grass did not die.
