BACKGROUND

Due to the proximity of two new properties to the development boundary there was insufficient space for the height difference of 4.4m to be dealt with by a natural slope.

Our Value Engineered SOLUTION

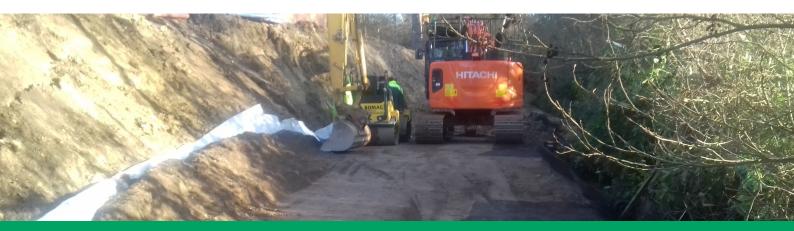
To deal with this a 300mm foundation pad of compacted MOT Type 1 above a layer of Ekotex geotextile was detailed. Additi onally a drainage layer of Duodrain and a drainage pipe was installed behind the reinforced soil block.

The reinforced soil block comprised 6m long horizontal layers of Stratagrid at 500mm vertical spacings, and a compacted 'well graded granular backfi II'; this was chosen to enable construction to continue almost uninterrupted during the adverse weather.

The 45 degree reinforced slope was fi nished with a 150-200mm layer of seeded topsoil and a Landlok Turf Reinforcement Mat to minimise surface erosion and provide a sustainable, maintenance free vegetated face.
